Subject: Boeing EQA Report - Aero Mexico 737-800 XA-ADV Radome Damage on
Approach Tijuana, Mexico, 12 Dec 2018

Equipment Quality Analysis Report

TO: Air Safety Investigations (ASI) **EQA NUMBER:** AS12941

SUBJECT: *Radome Damage on Approach*

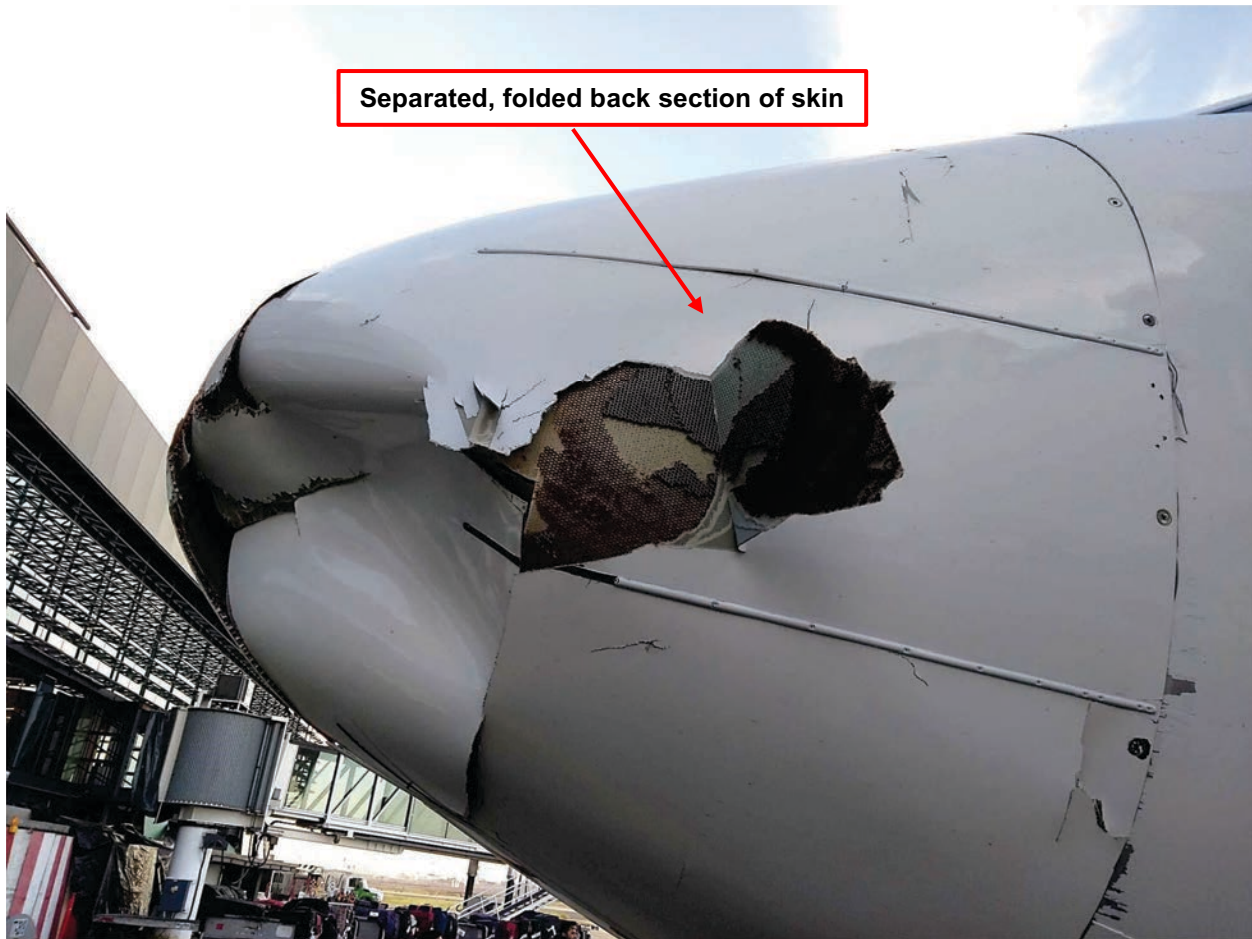
It was reported that the radome had a large area of damage on the left side, with a separated section of skin folded aft. Photos from the operator showed that the underlying radar antenna was bent, and the base of the antenna was fractured. AMX reported that the radome was repaired May 04, 2017, and was installed May 10, 2017, according to records from the previous operator.

Figure 1 was provided by the operator and is an image of the damaged radome prior to removal.

Figure 1 – Damaged radome prior to removal from the aircraft

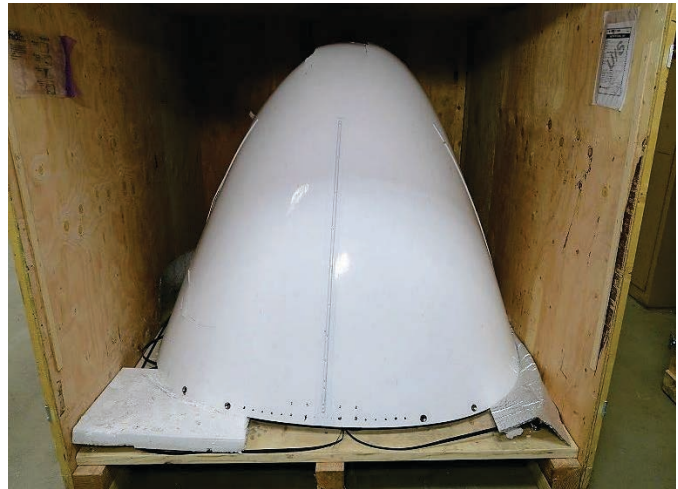
Overviews of the radome as received by EQA are shown in Figure 2 and Figure 3. The information stamp on the interior of the radome is shown in Figure 4.

Figure 3 – Radome as received

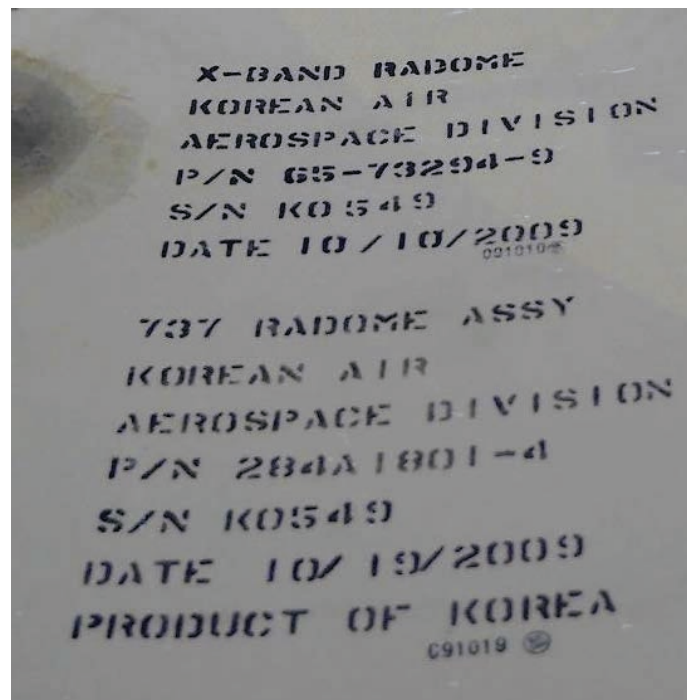
Figure 4 – Information stamp

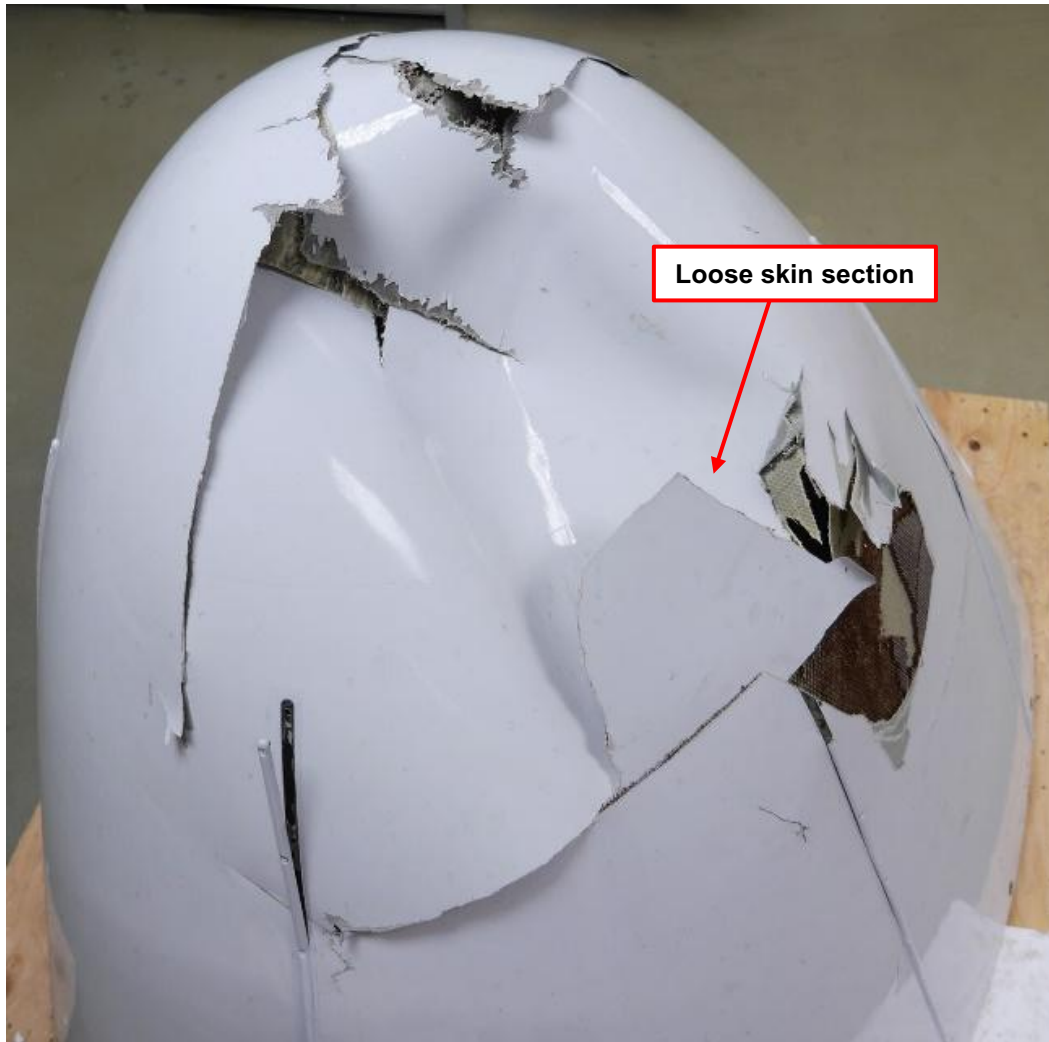
The radome was removed from the crate and examined. Figure 5 through Figure 7 are overviews of the exterior of the radome, with anomalies detailed. A section of the exterior radome skin had separated from the honeycomb structure, and was attached only in a small area aft of the damage, as seen in Figure 1. As seen in Figure 5, the skin section had been removed and lodged in the crevice of the fractured radome prior to arrival at EQA.

Figure 5 – Overview of damage area

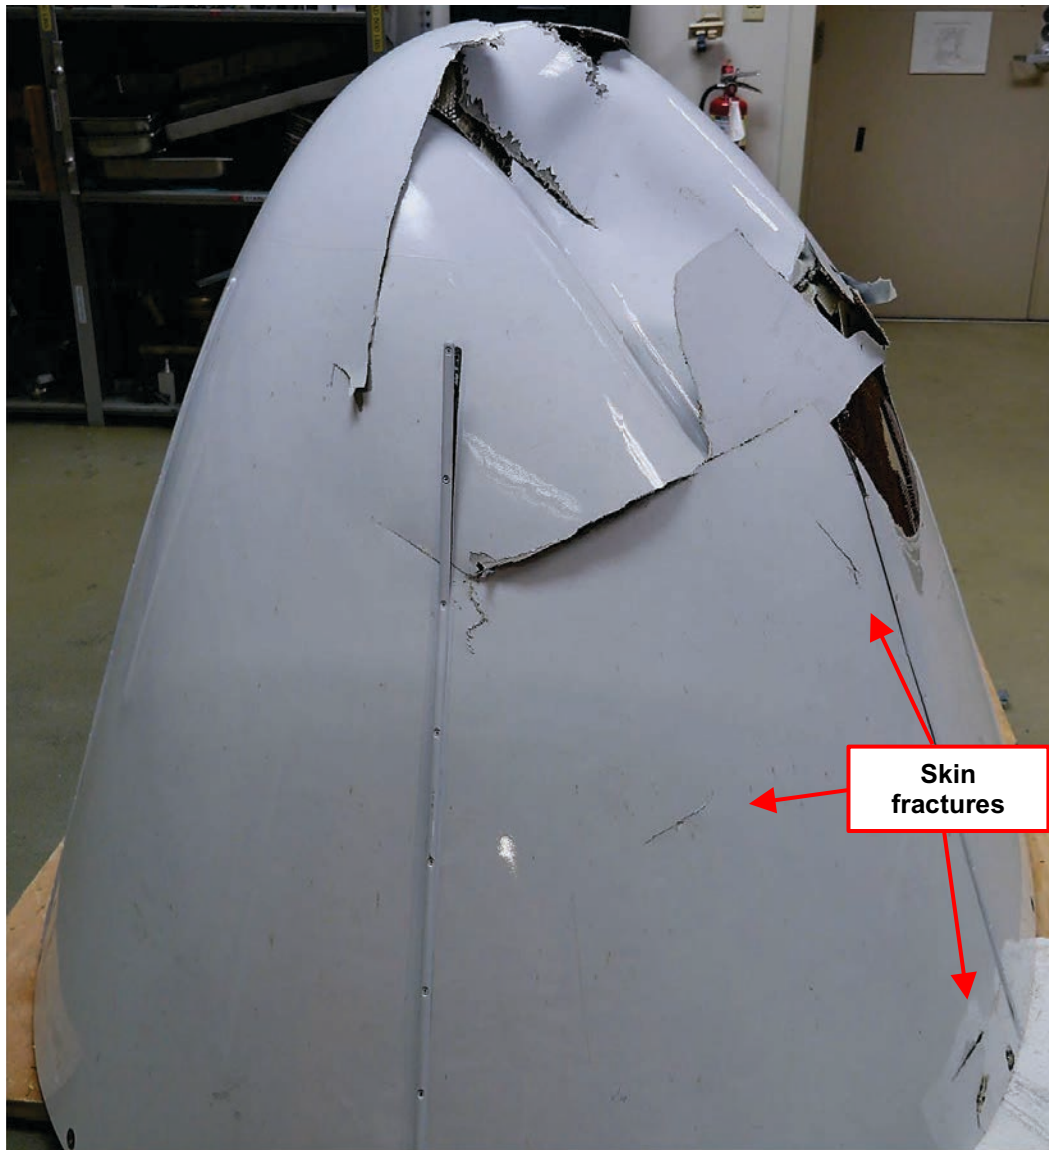
The majority of the damage was on the forward left side of the radome, with isolated fractures in the skin away from the damage area, as seen in Figure 6.

Figure 6 – Radome bottom left view

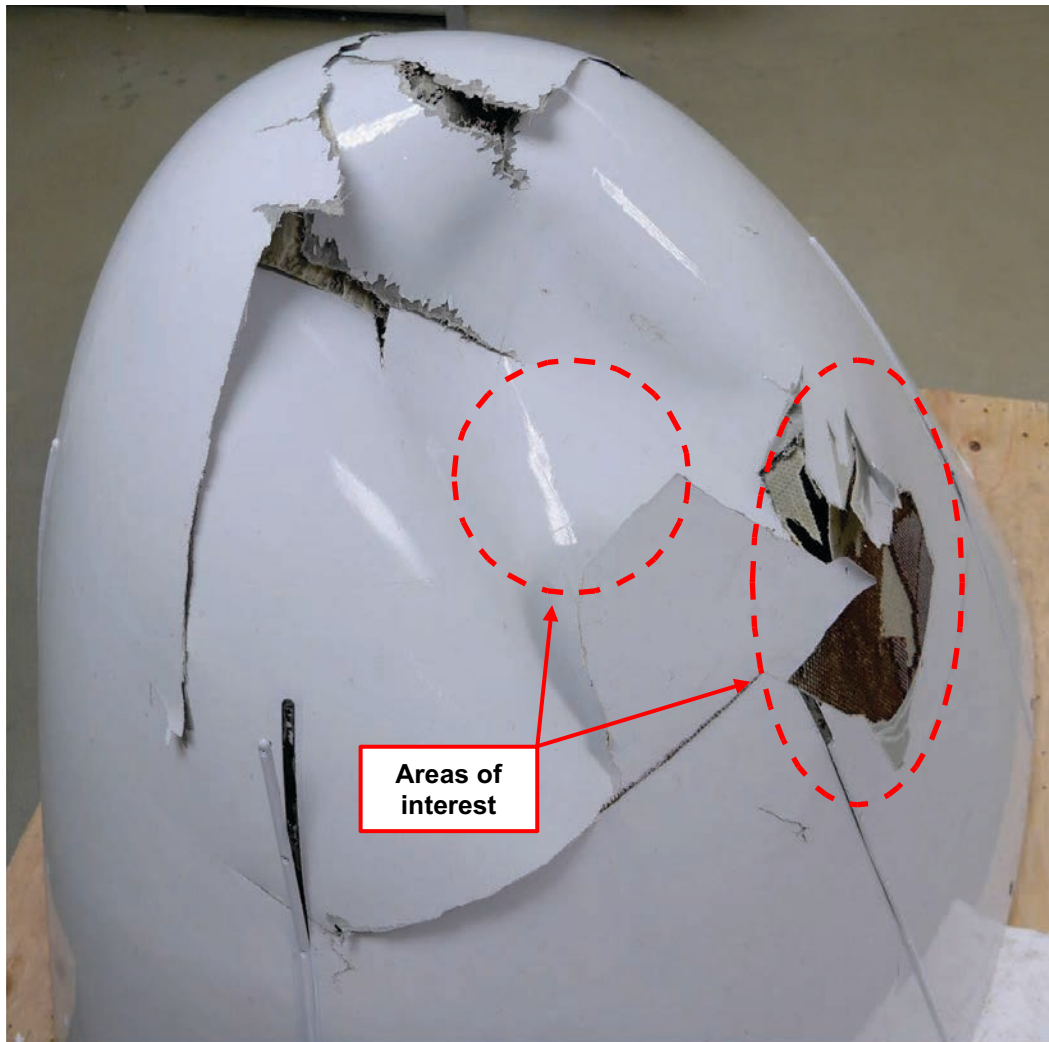
The areas of greatest interest were at the low point of the indentation and the area where the skin section was removed, as indicated in Figure 7.

Figure 7 – Radome bottom left view

Inspection of the indentation noted no evidence of an impact. The impact of a hard bodied, or manmade, object was ruled out due to a lack of distinctive marks in the radome surface.

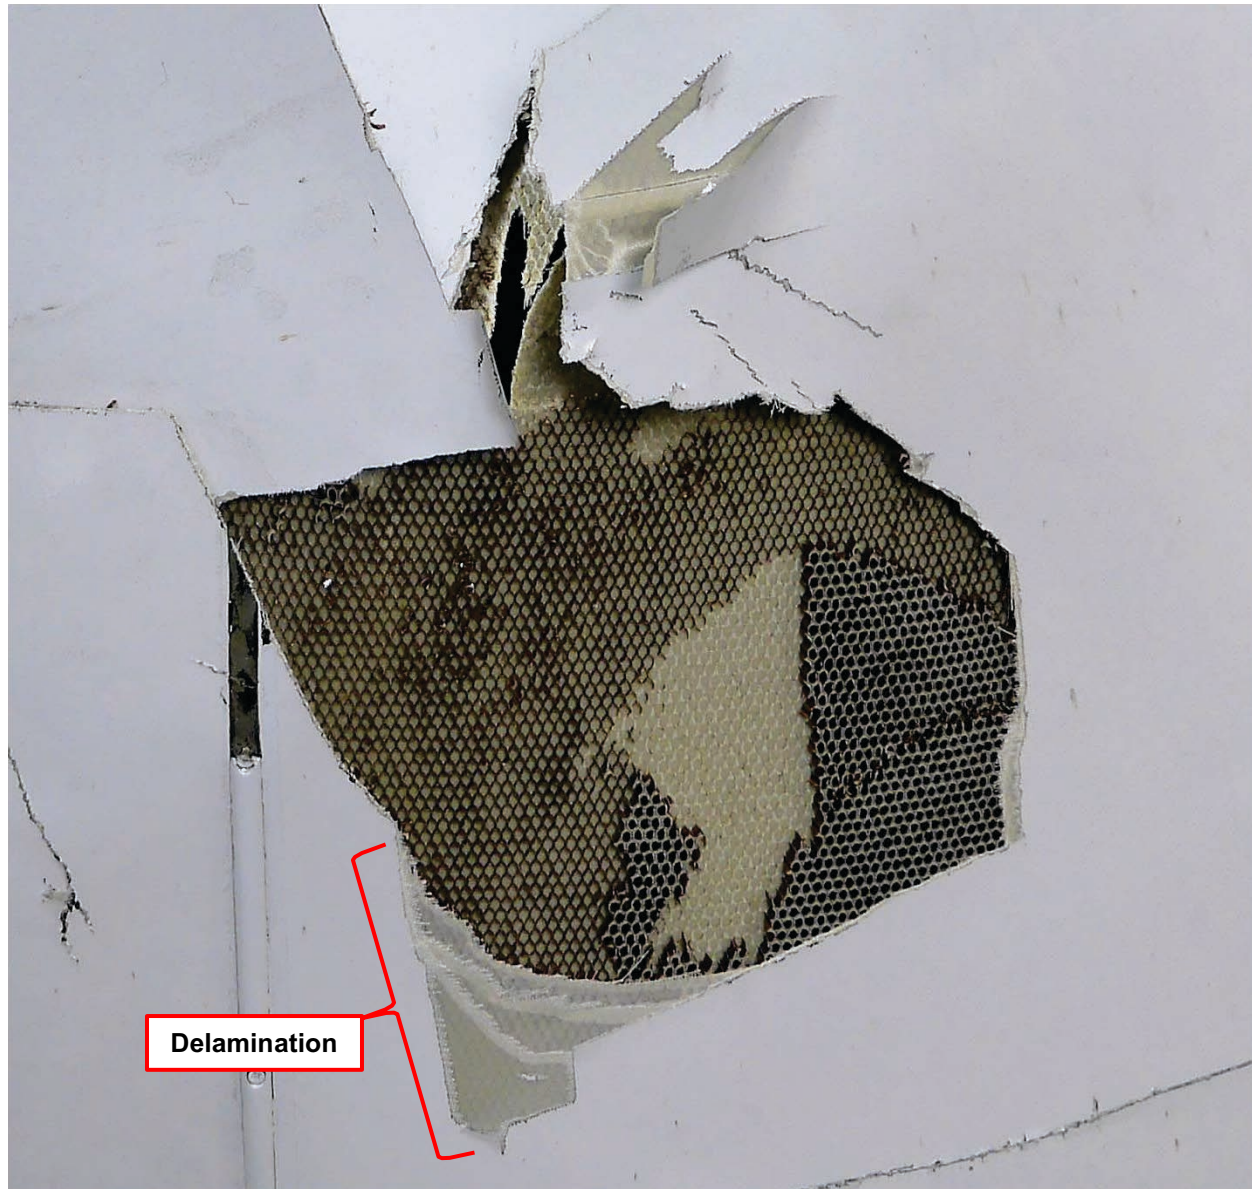
Figure 8 is a view of the damaged area where the section of skin ply separated from the radome. The visible layers of laminate illustrated in Figure 8, where the skin section was still attached in Figure 1, were noted as delamination between the plies of exterior skin.

Figure 8 – View showing area of separated skin ply section

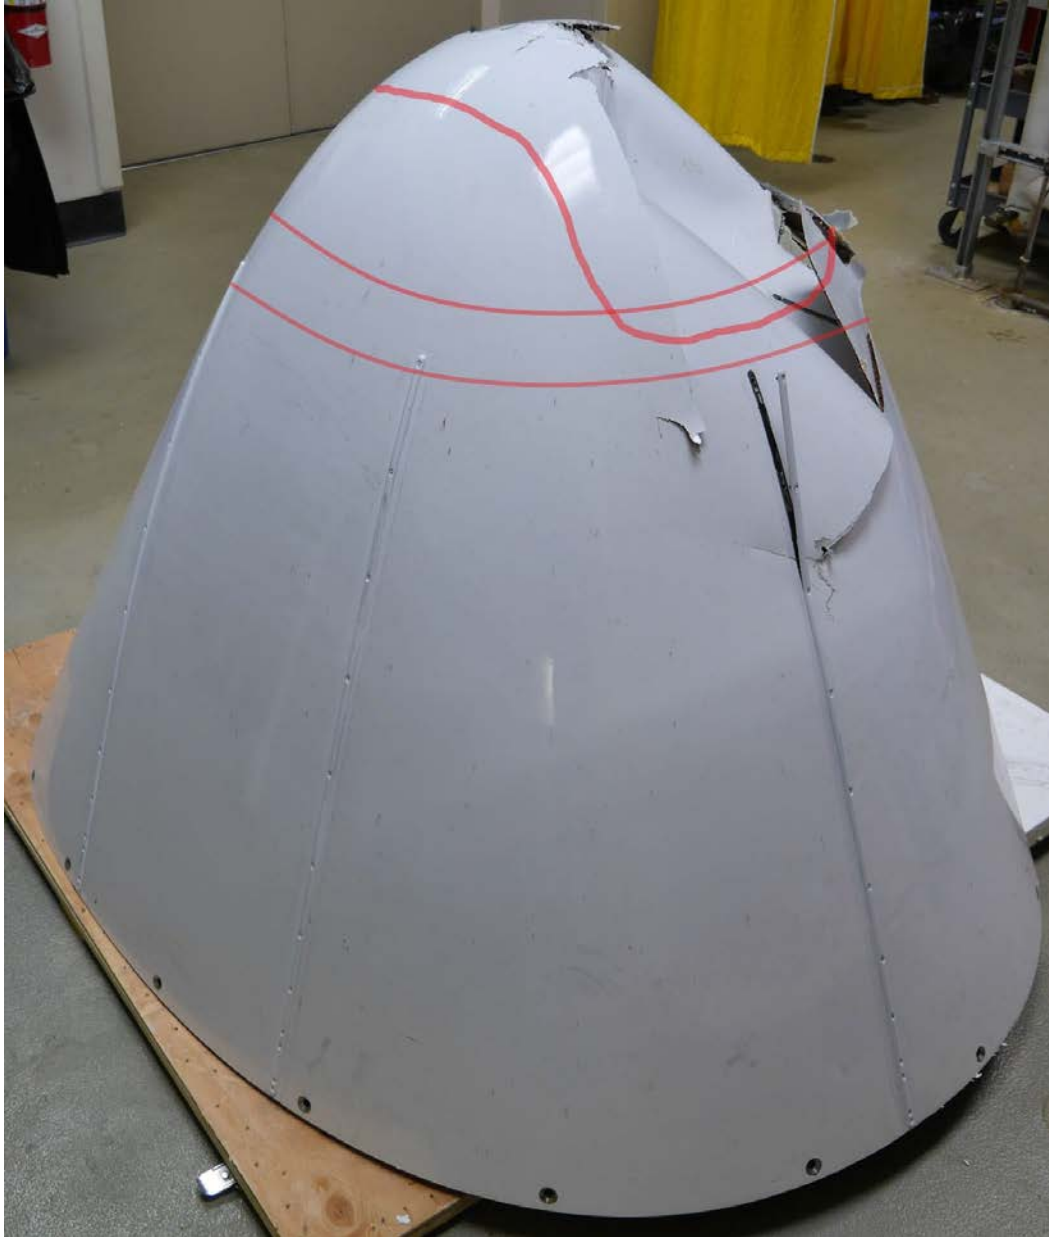
There were two raised circumferential lines, possibly indicative of layers of paint, visible near the forward area of the radome. An oval surface feature was also visible around the nose of the cone. The red lines in Figure 9 illustrate approximate locations of the raised surface features.

Figure 9 – Radome overview showing where raised surface features were noted

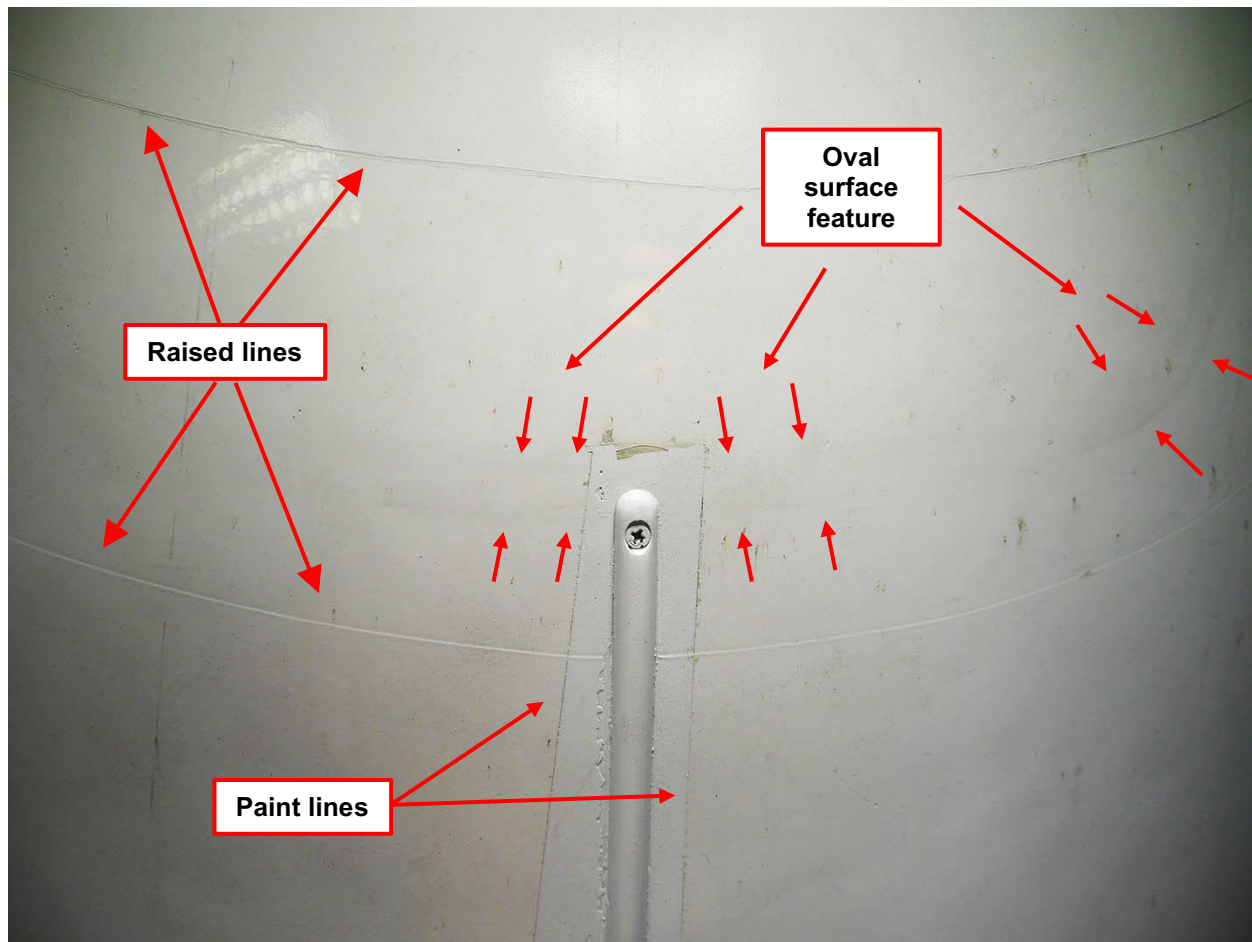
The various surface features are illustrated in Figure 10. Also noted were distinct paint lines adjacent to the lightning diverter straps, which were determined to be most likely indicative of touch-up painting following the application of reference (c) service letter.

Figure 10 – Forward surface of radome showing raised circumferential lines and painted diverter strap

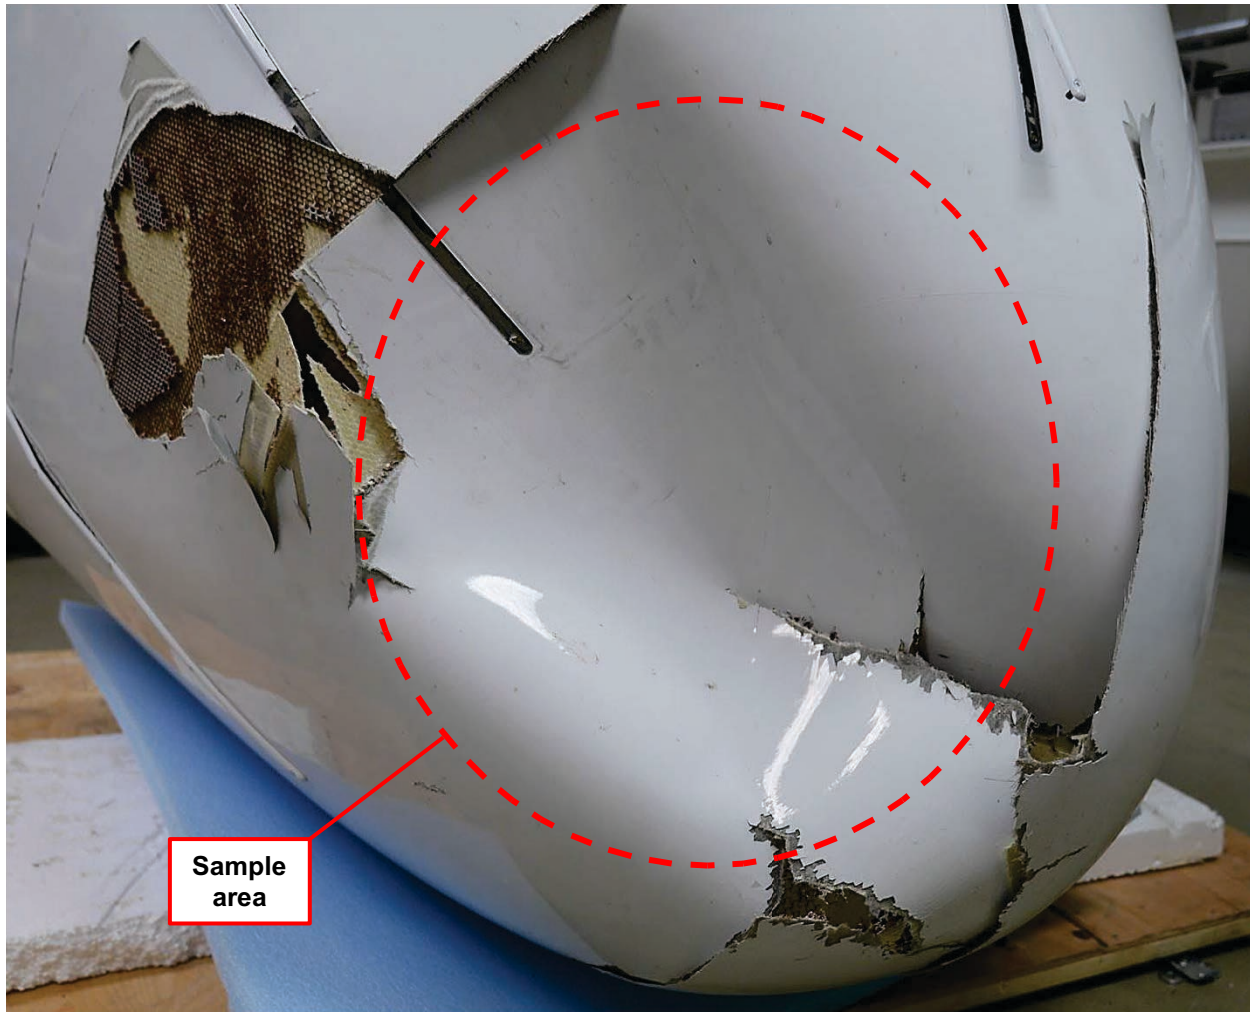
No blood or tissue (snarge) from a bird strike was evident. An alcohol swab was used to collect potential DNA evidence for analysis using the Smithsonian Institution Feather Identification Lab instructions, available from the Federal Aviation Administration. The samples were hand carried by NTSB representatives for shipment to the appropriate laboratory. Figure 11 illustrates the DNA sample area.

Figure 11 – Overview showing sample area

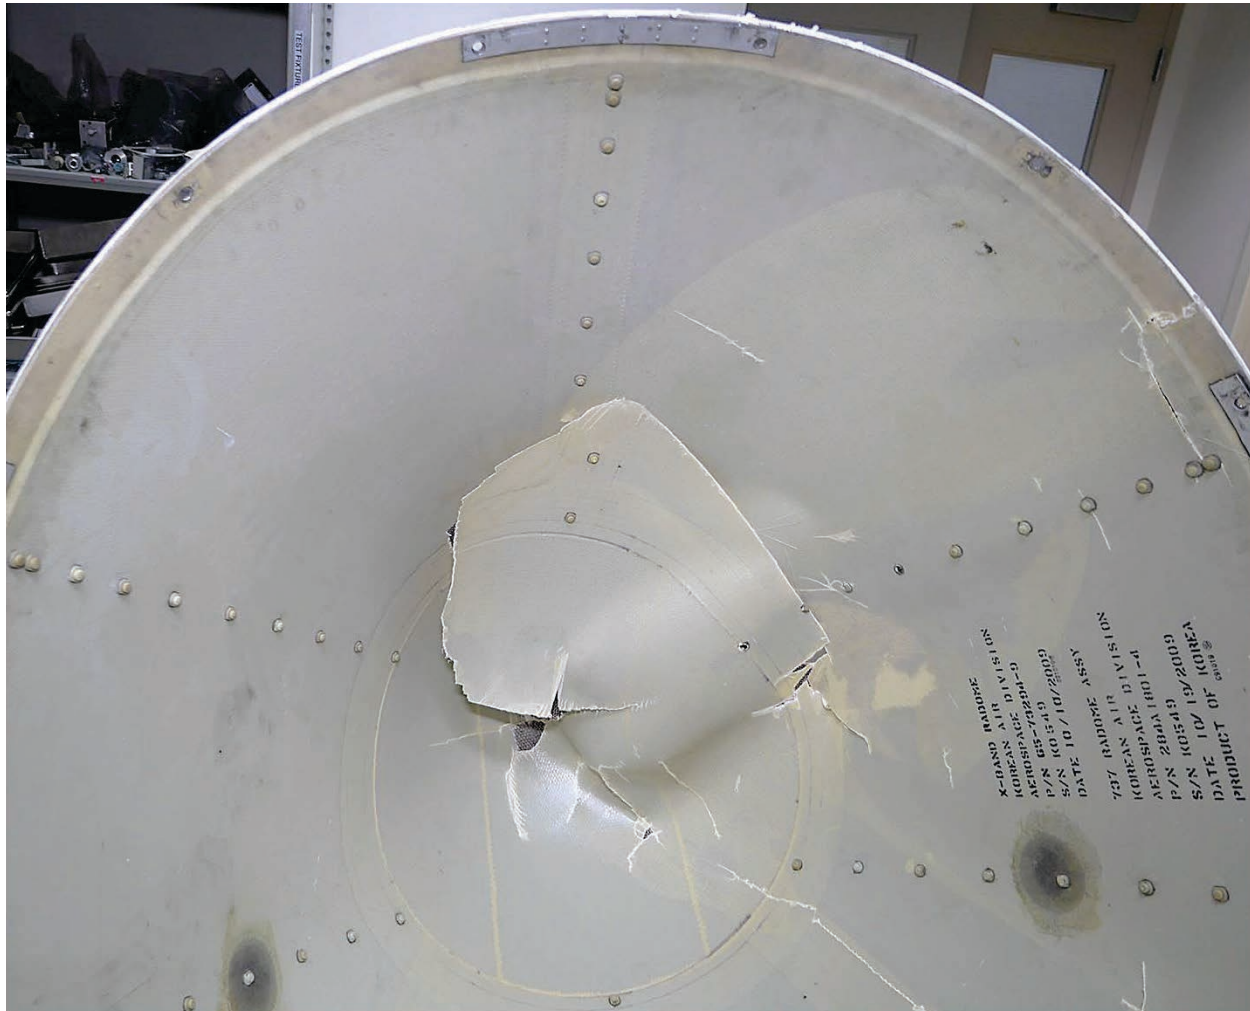
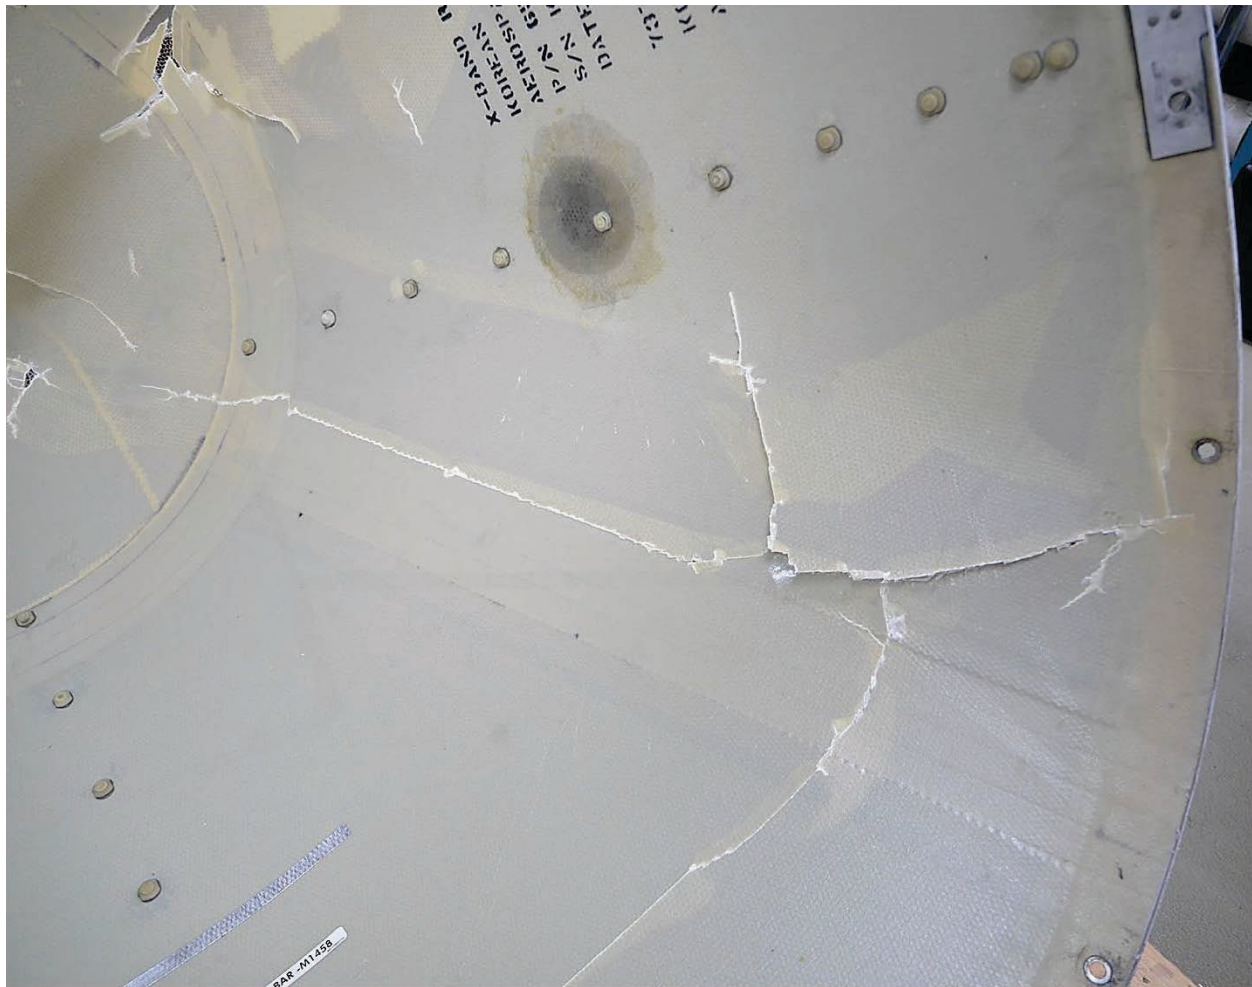
The radome was placed on the bottom side to inspect the damage to the interior, as shown in Figure 12 and Figure 13.

Figure 12 – Radome interior

Figure 13 – Radome interior

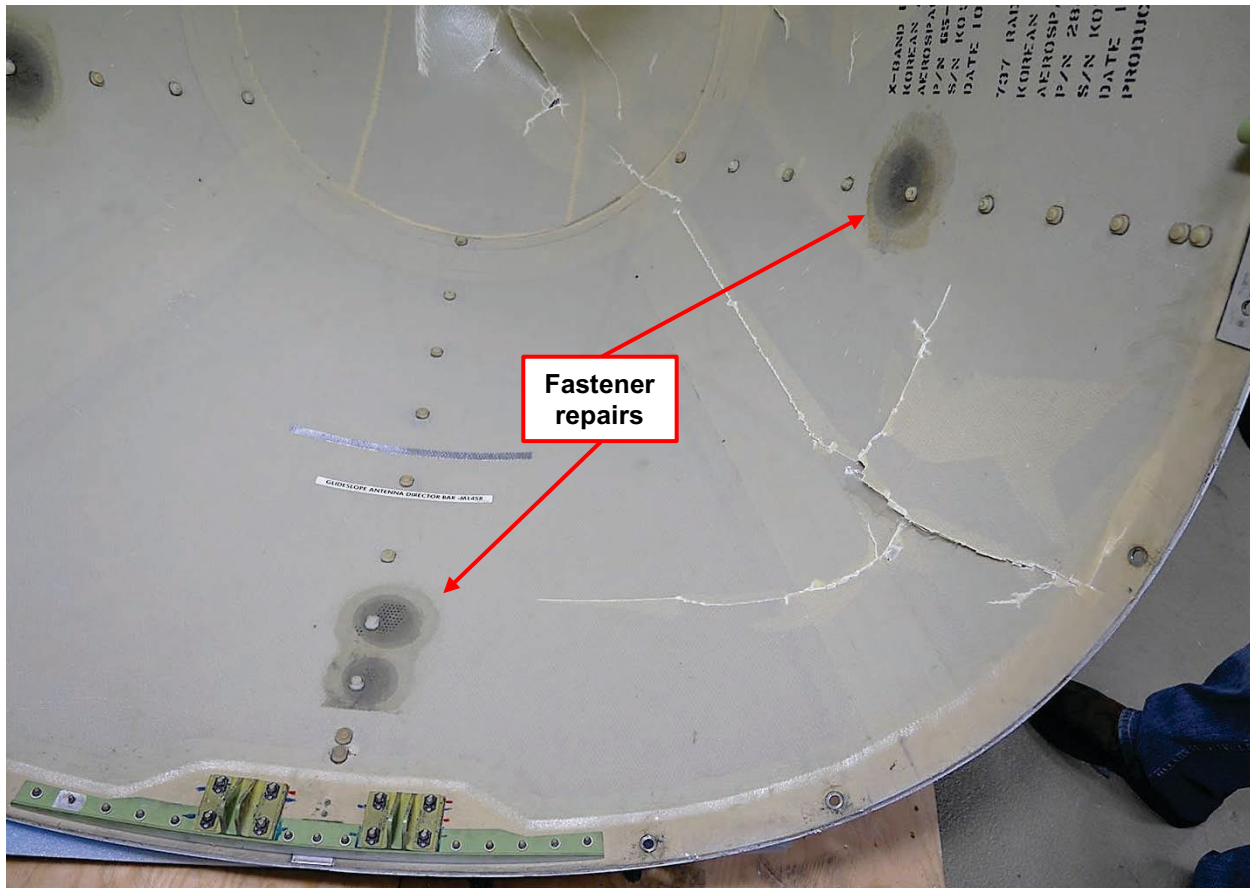
Dark areas around the diverter strap fasteners, shown in Figure 14, were identified as repairs related to the reference (c) service letter.

Figure 14 – Radome interior showing fastener repairs
